東アジア地域における
海上安全と事故調査のためのセミナー

報 告 書

平成23年3月

財団法人 海難審判協会

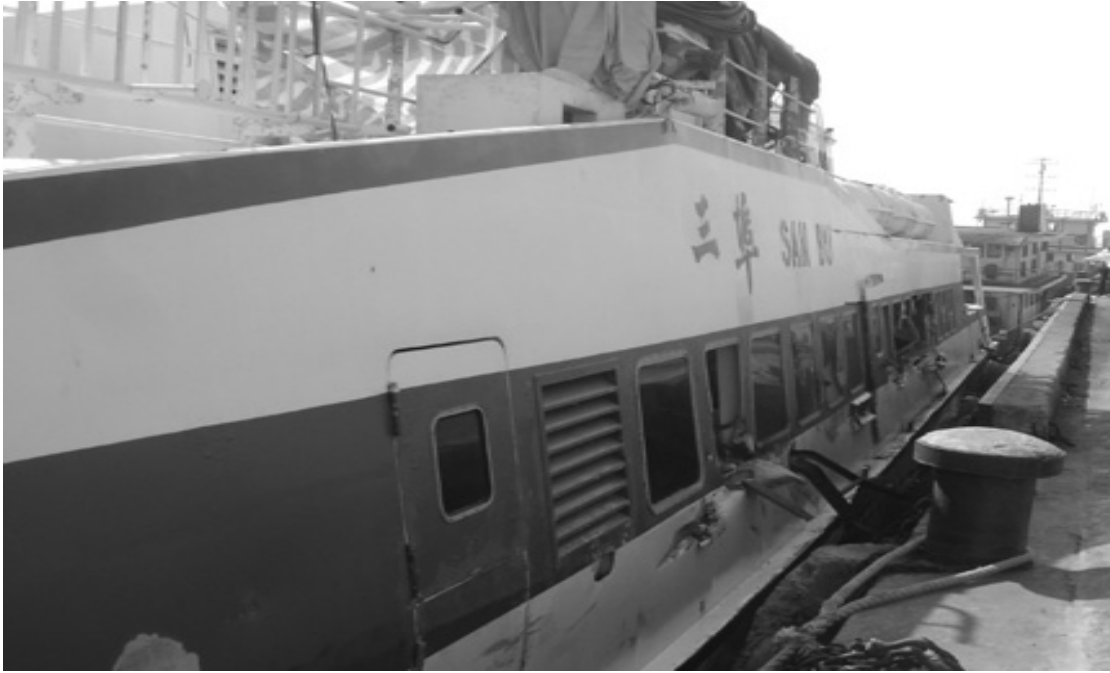
1.9.1 San Bu

The accident caused 1 person died at scene, and another 1 died after transferring to hospital the same day, 9 passengers injured and the ship's hull badly damaged.

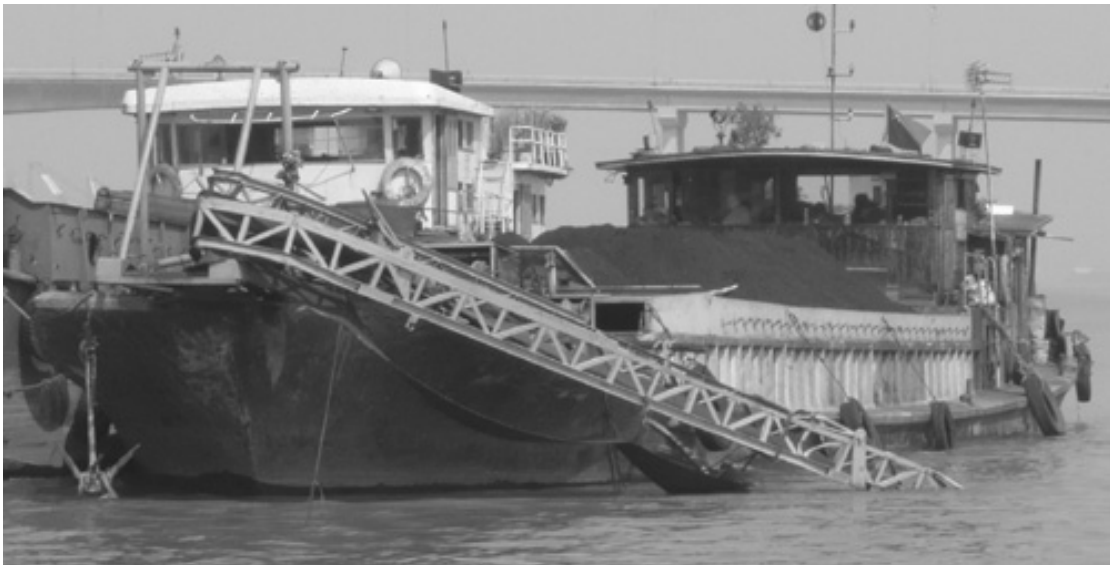
1.9.2 Yue Guang Zhou Huo 0217

The conveyer at bow was broken off.

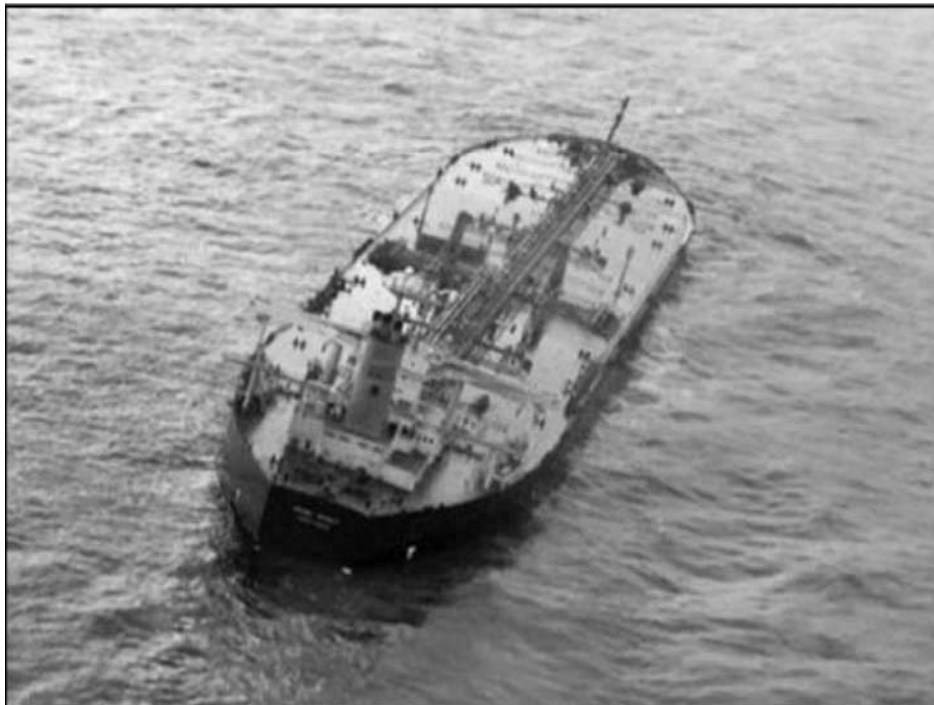
- 4.1.21 *“Hebei Spirit”* was not able to report the accident to the shipowners at the time because the crane hooks of *“Samsung No. 1”* had damaged the satellite communications dome on the main mast in the collision. On acknowledging the leakage of oil, the ship’s crew implemented the ship’s emergency response plan for dealing with an oil pollution incident. They checked the ullages of all the cargo oil tanks, and sounded all the ballast tanks and void spaces to make sure the only leaks were in way of the Nos. 1, 3 & 5 cargo oil tanks. The Chief Engineer reported that there were no leaks in the engine room tanks (fig.3).

Fig. 3 *“Hebei Spirit”* after collision

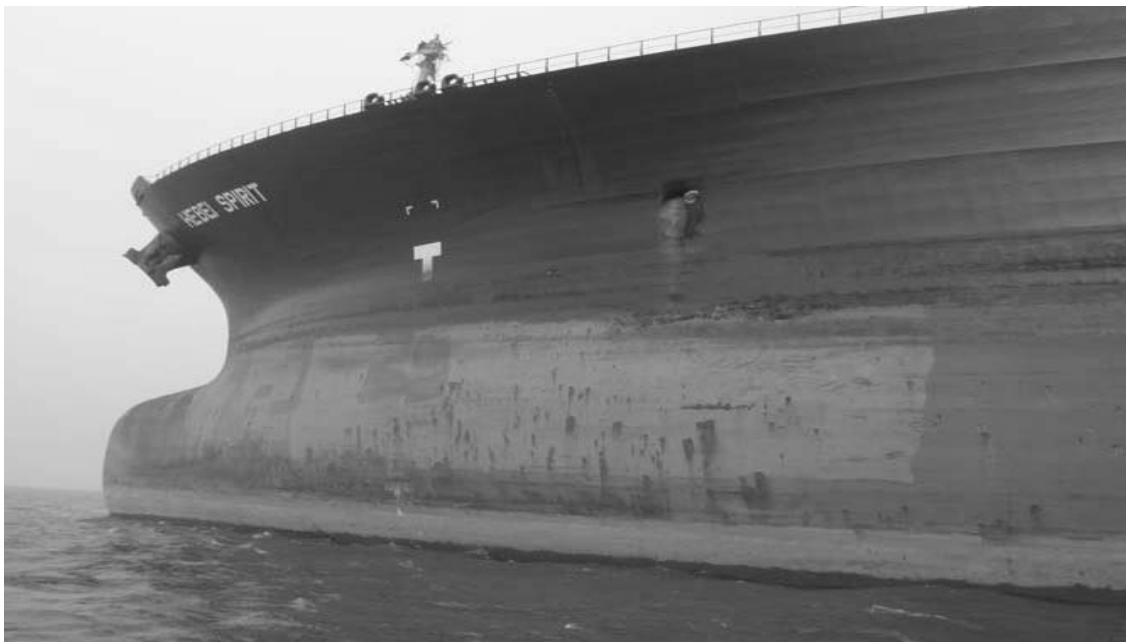
6.2 Hebei Spirit は 263,541 トンの原油を搭載していた。事故当時、同船は大山沖に着錨して荷揚げの待機中であった。事故の直前、タグ船団が Hebei Spirit の前方を右舷方向から左舷方向に横切る形で通過した。タグの通過後、曳航索が分断されてクレーン・バージが Hebei Spirit の方向に流された。その結果、クレーン・バージはタンカーの左舷船首部に接触し、Hebei Spirit の左舷側第 1、第 3 及び第 5 貨物油タンクが破孔して、付近の海域に重大な油濁を発生させた。

Fig. 4 Damaged No. 1 port cargo oil tank

6.7 **Hebei Spirit** は、事故後、損傷タンク内の貨物油を他のタンクに移送すると同時に、損傷タンクの側面に衝突マットを固着させるなど、汚染規模の拡大を防ぐための努力を行った。

6.8 同時に、**Hebei Spirit** の船長は、同船を右舷側に傾斜させることによって損傷貨物油タンク内の油の水位を下げるため、右舷バラスタタンクへの意図的な注水を実施した。これらの対策措置は、油の流出量を抑制する上で一定の効果があったものと思われる。事故発生後に同船の船長及び乗組員が行った行動

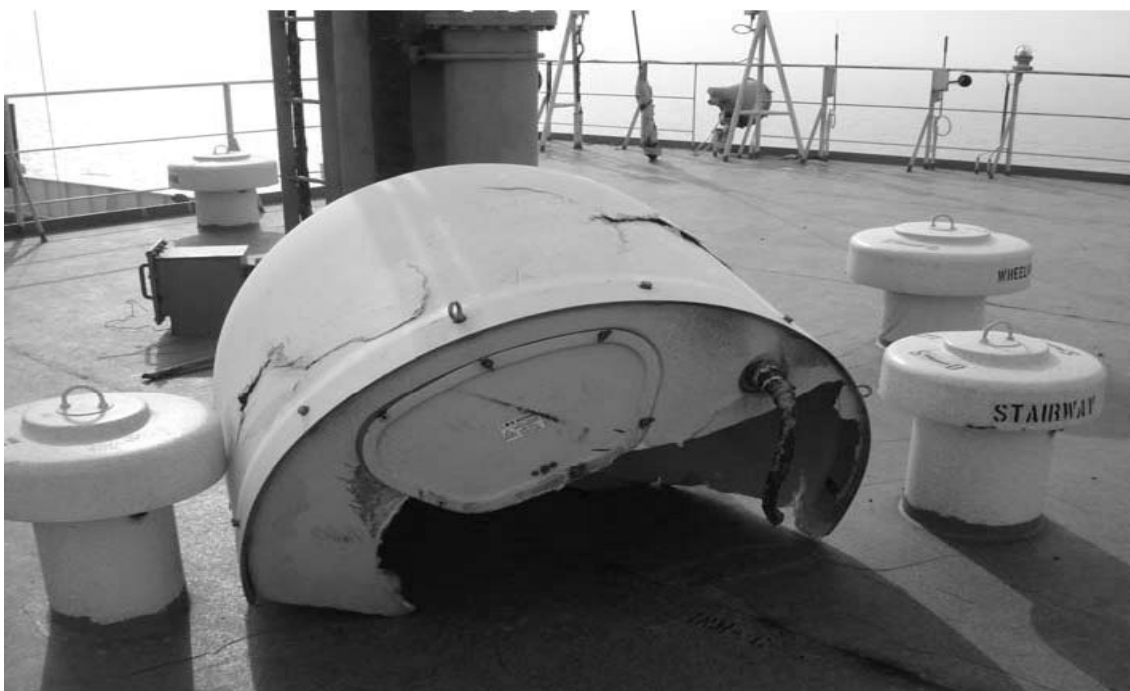
Fig. 5 Damaged satellite communication dome at the main mast

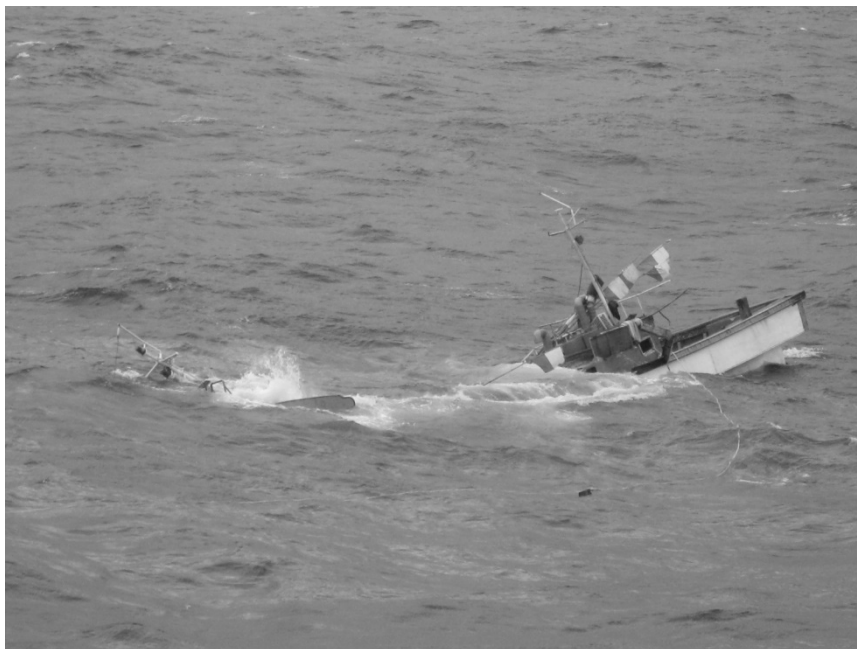
Figure. 2 -*No.3 Dae Kyung* semi-submerged in water after collision

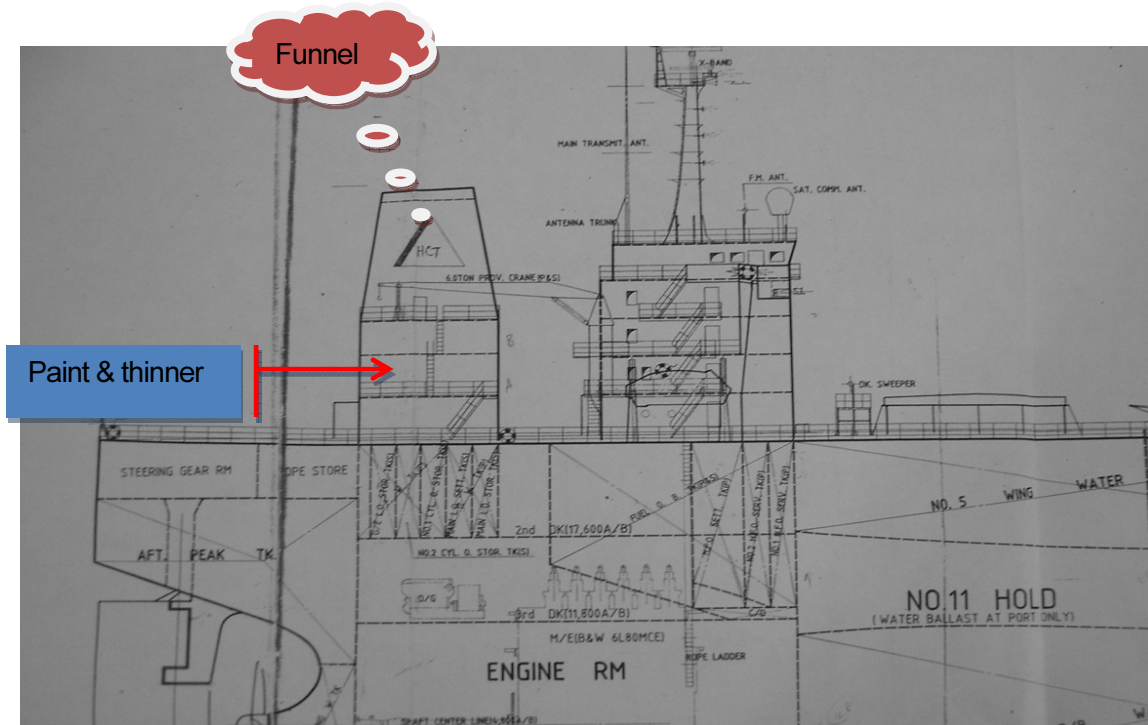
火災事故を発生させることになった現場に塗料及びシンナーを積み込んだ際、積み込み作業の前後に、合計 1,000 個の収納容器について損傷の有無を確認するための検査が十分に行われていなかった。損傷容器からの液の漏出はすでに積み込み作業の時点から始まっていたが、船長はそのことに気付かず、現場の巡視強化を怠った上、積み込んだ材料を保護するために必要な防水材やアスベストによる被覆措置も講じていなかった。唯一、ビニール製のシートが上掛けとして使用されていたが、これは高熱が発生した場合や火片が付着した場合、火災の危険を伴うものであった。

Figure 2 The stored position of paints and thinner

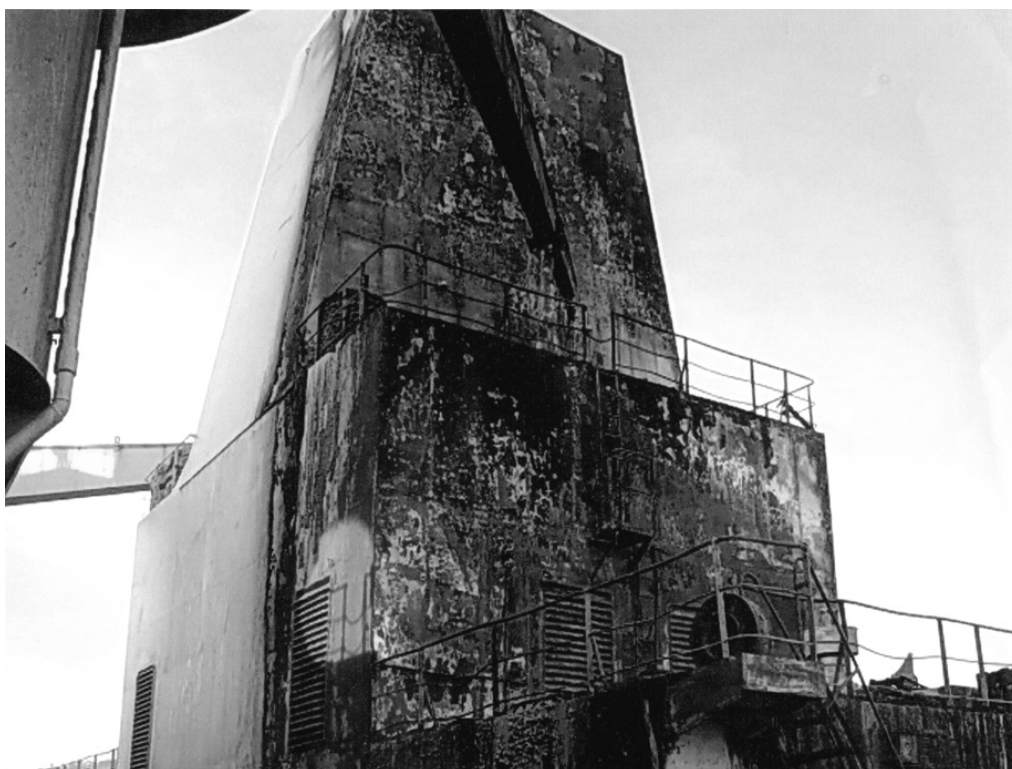
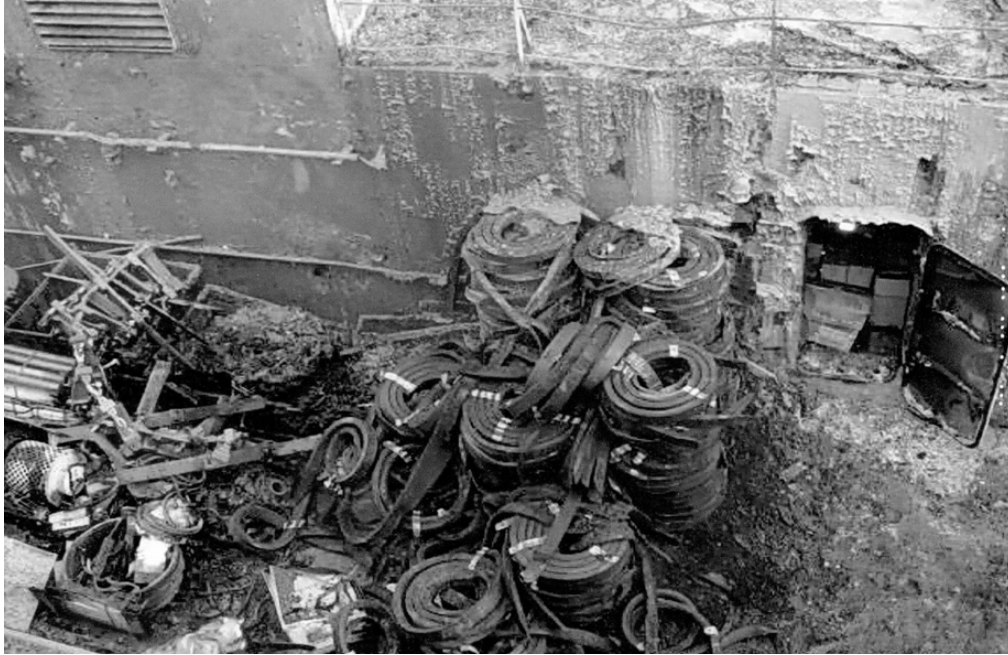
Figure 3 After the fire

件下において、煙突から出た煤煙と火片が塗料及びシンナーから漏出した強力な可燃ガスに引火し、火災が発生したものと想定される。

As a result of the accident, all paints and thinners located in the accident area were ruined. In addition, various electrical facilities (panel, board, fan motor, etc.) in the emergency generator room which was close to the accident area, and ship's stores placed around the area were damaged. The funnel wall and decks were severely damaged and ruined with smoke.

- A. 塗料及びシンナーの取り扱いは、取り扱い及び保管の安全に関する規則に基づいて適正に行わなければならない。
- B. 危険物質の移動、積み込み、保管等を行う場合は、保存容器の損傷または容器からの漏出の有無を慎重に点検すると共に、当該現場の巡視を強化しなければならない。
