4 各国等のプレゼンテーション (1) オーストラリア

The Experts Meeting on Marine Casualty Investigations
Tokyo 25 and 26 June 2008
Polar Foley, Director Surface Safety Investigation
Australian Transport Safety Bureau

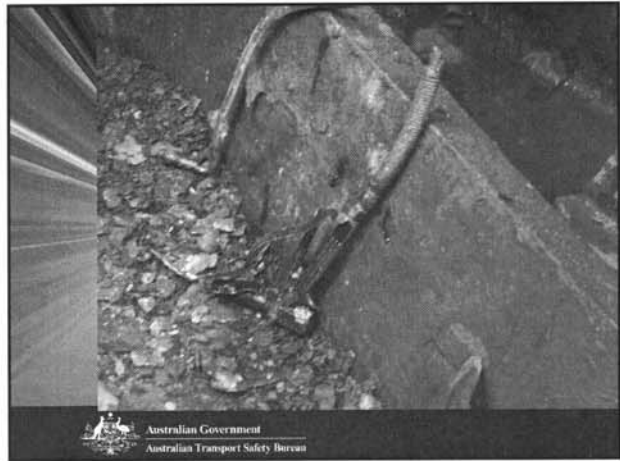
Number 1 port topside ballast tank plan

- Explosion was caused when paint vapours were ignited inside the tank
- Proximal factors included: poor ventilation, use of excess thinners, high ambient temperature, use of non intrinsically safe equipment, lack of appropriate functioning gas analysis equipment

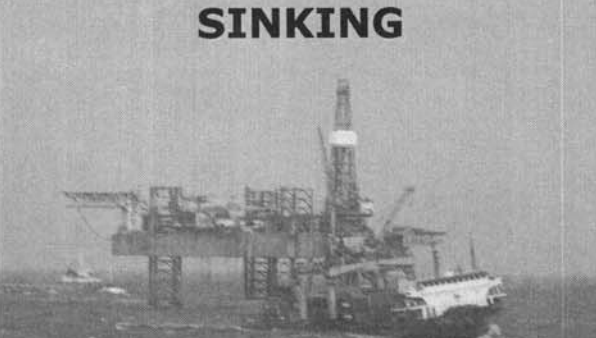
SINKING

Flag India, Container vessel, age 27 yrs
Primary cause: Technical failure, poor maintenance, inclement weather

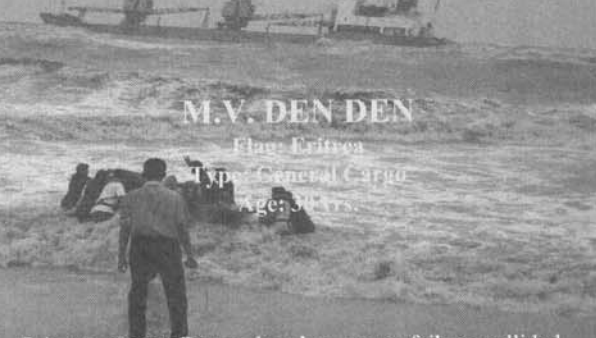
M.V. DEN DEN

Flag: Eritrea
 Type: General Cargo
 Age: 30 yrs.

Primary causes: Dragged anchor, power failure, collided with buoy and ran aground off New Mangalore

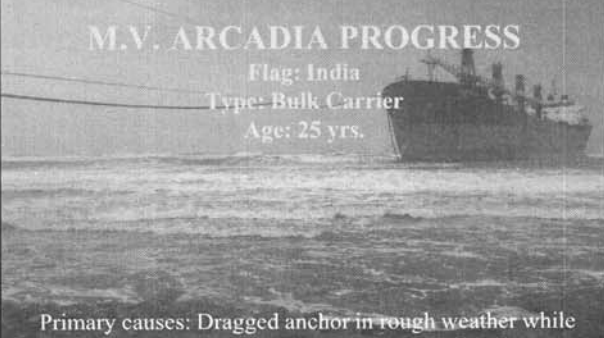
M.V. ARCADIA PROGRESS

Flag: India
 Type: Bulk Carrier
 Age: 25 yrs.

Primary causes: Dragged anchor in rough weather while awaiting berth. Ran aground off Porbandar

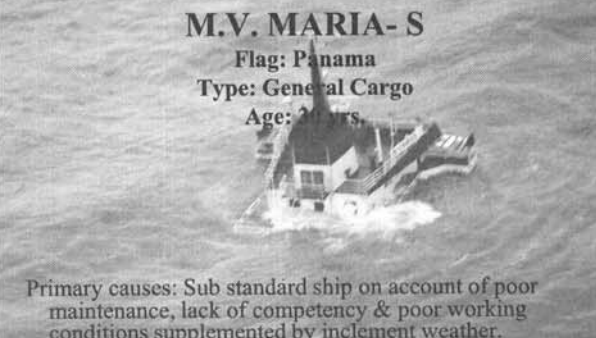
M.V. MARIA-S

Flag: Panama
 Type: General Cargo
 Age: 20 yrs.

Primary causes: Sub standard ship on account of poor maintenance, lack of competency & poor working conditions supplemented by inclement weather. Vessel eventually sank while entering navigational channel of Cochin harbour

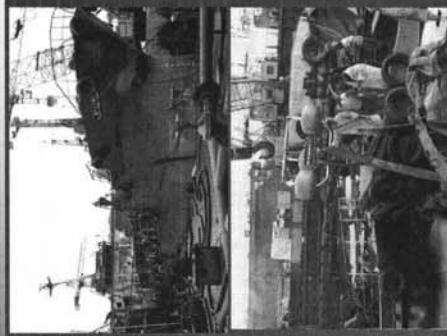
MT. KHARISMA SELATAN (DEC 2007)

- **Years Built:**
 - 1986
- **Dockyard:**
 - Murakami Hide Shipyard, Japan
- **Type of Accident:**
 - Capsize
- **Location:**
 - Mirah Pier, Surabaya
- **Findings:**
 - Ship loaded with no load line certificate
- **Contributing Factors:**
 - Lack of Crew's Understanding on ship operation procedure
 - No Load line Installed
- **Recommendation:**
 - Enhancing supervision on ISM-Code Implementation;
 - Enhancing on ship's boarding control;
 - Enhancing ship maintenance Plan;
 - Enhancing Crew's Training on ship's familiarity;

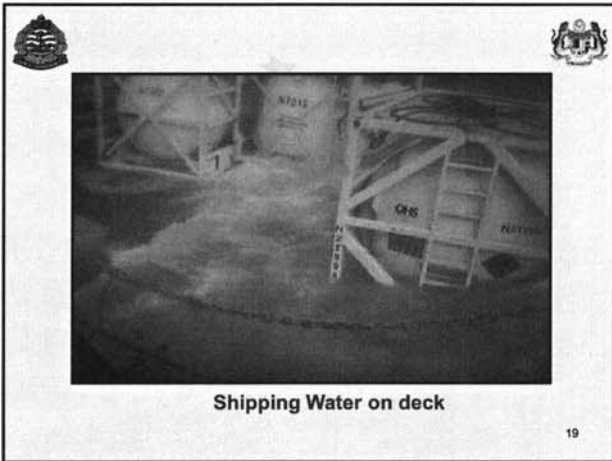
Shipping Water on deck

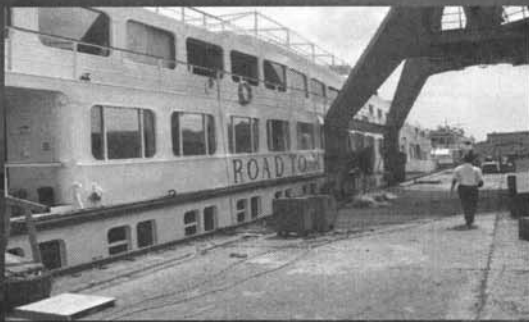
- Myanmar Registered inland vessel mv. Road to Mandalay, Off No. 8199, GT. 1916 was grounding due to hitting by Cyclone "Nargis" about 55hrs on 03.05.2008 within Myanmar (Yangon) river in psn: Lat. 16 49.51 N , Long. 096 06.9E while she waiting to enter the Sinmalaik Dockyard at mooring buoy. All crew ,19, Myanmar were saved alive.

M.V road to Mandalay portside alongside at Sinmalaik Dockyard after grounded by Cyclone "Nargis"

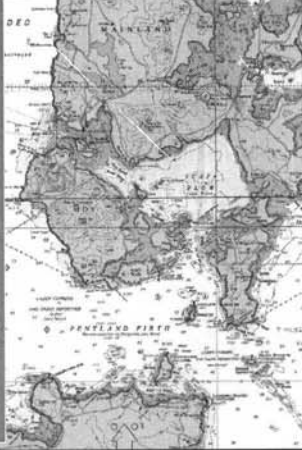
Oil terminal on island of Flotta, where crude oil is received from oil fields by pipeline, and loaded into tankers. Used for **ship-to-ship transfer**

Scapa Flow is entered through **Sound of Hoxa**, the narrowest part
