東アジア地域における
海上安全と事故調査のためのセミナー

報 告 書

平成23年3月

財団法人 海難審判協会

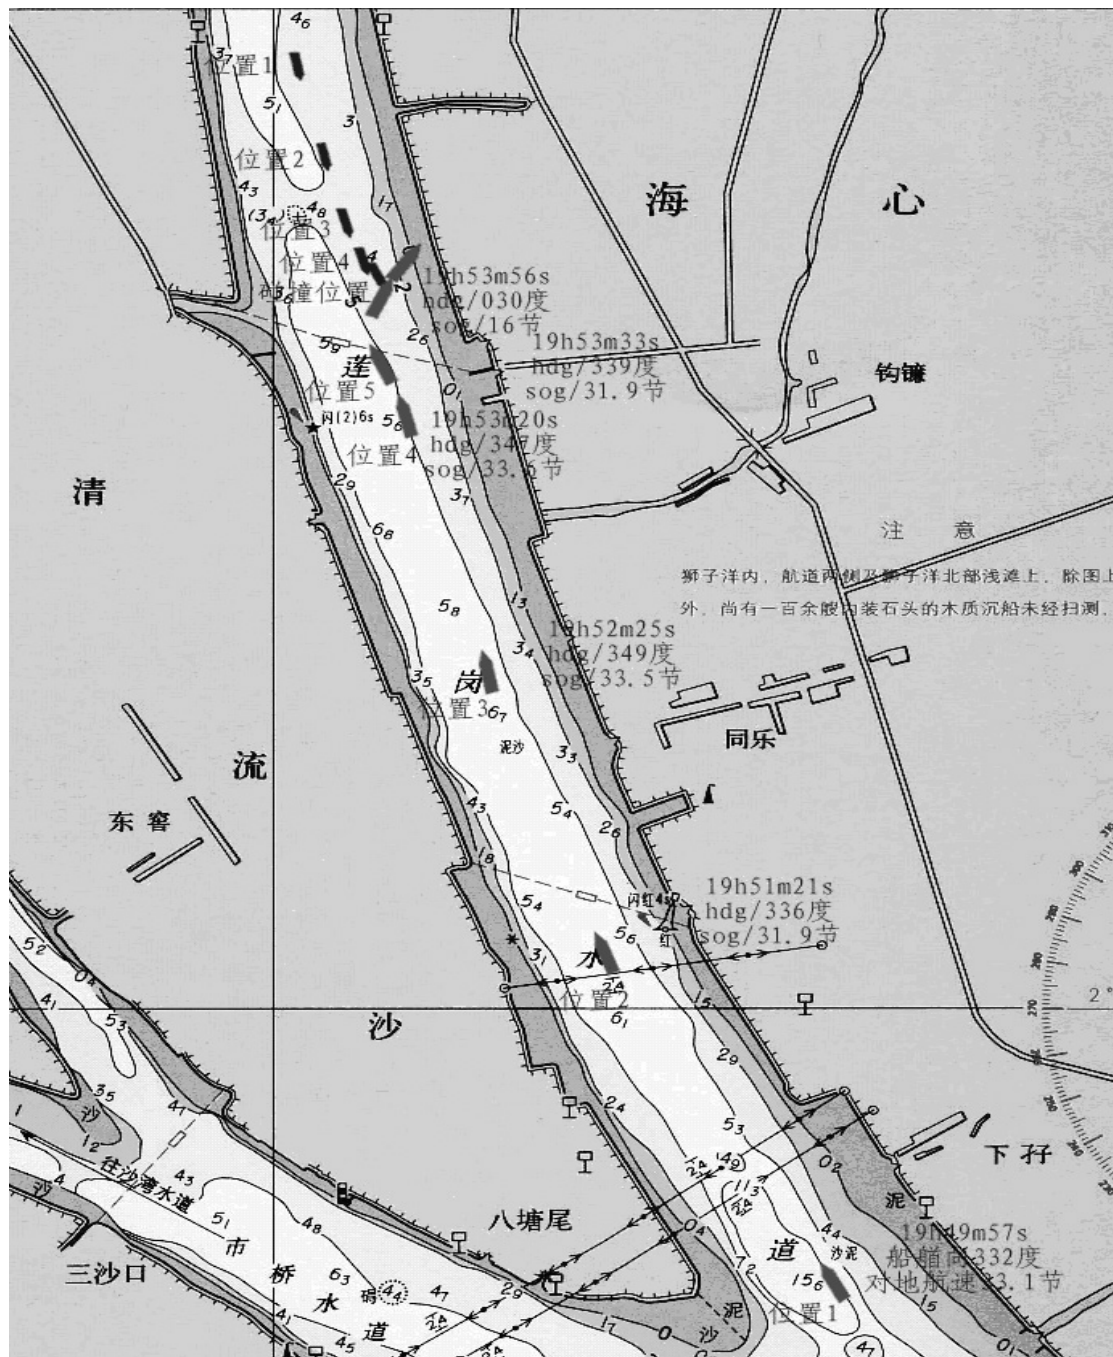
2.2.4 Collision diagram

waters shall give way to the non-high speed crafts; therefore, San Bu was the ship in this case to give way to Yue Guang Zhou 0217.

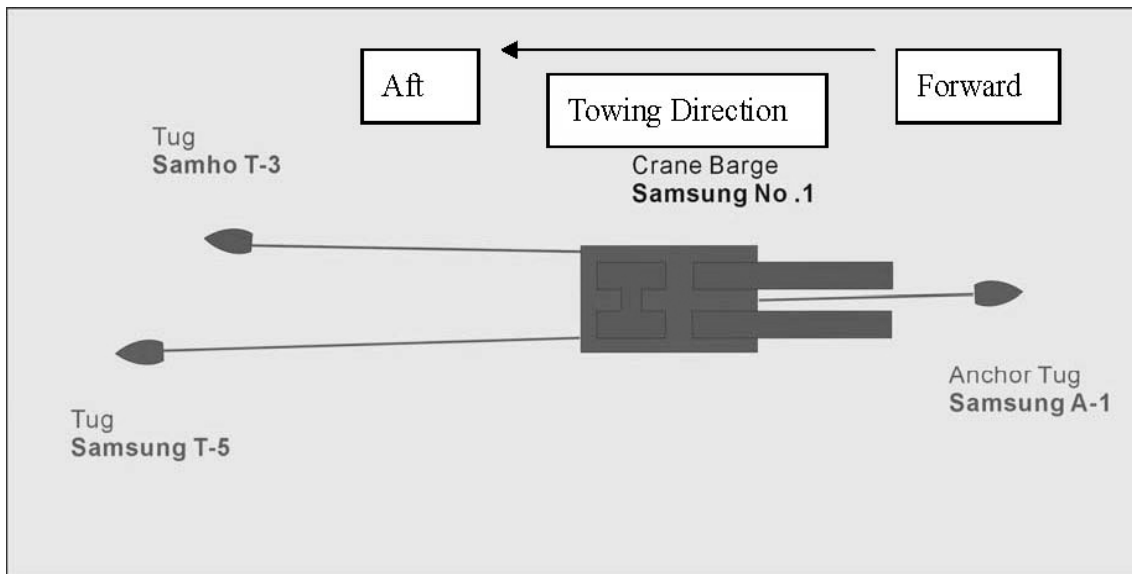
Fig. 6 Towing arrangement of the convoy

4.2.2 The towing convoy departed on its return voyage from Incheon at about 1450 on 6 December 2007 after work and headed south for Geoje (34°49'N 128°26'E). The crane barge "*Samsung No. 1*" was towed by the stern by two tugs, namely "*Samho T-3*" and "*Samsung T-5*". An anchor boat "*Samsung A-1*" was escorting at the other end of the crane barge (fig. 6). The towing wires at tug "*Samho T-3*" was approx. 400 metres and "*Samsung T-5*" was approx 420 metres. Both towing wires were at 48 mm in diameter. The Master of "*Samsung T-5*" had assumed the overall responsibility on navigational safety of the convoy. During the voyage, the communication between the four vessels was through VHF radio Channel 15 and occasionally via mobile phones.

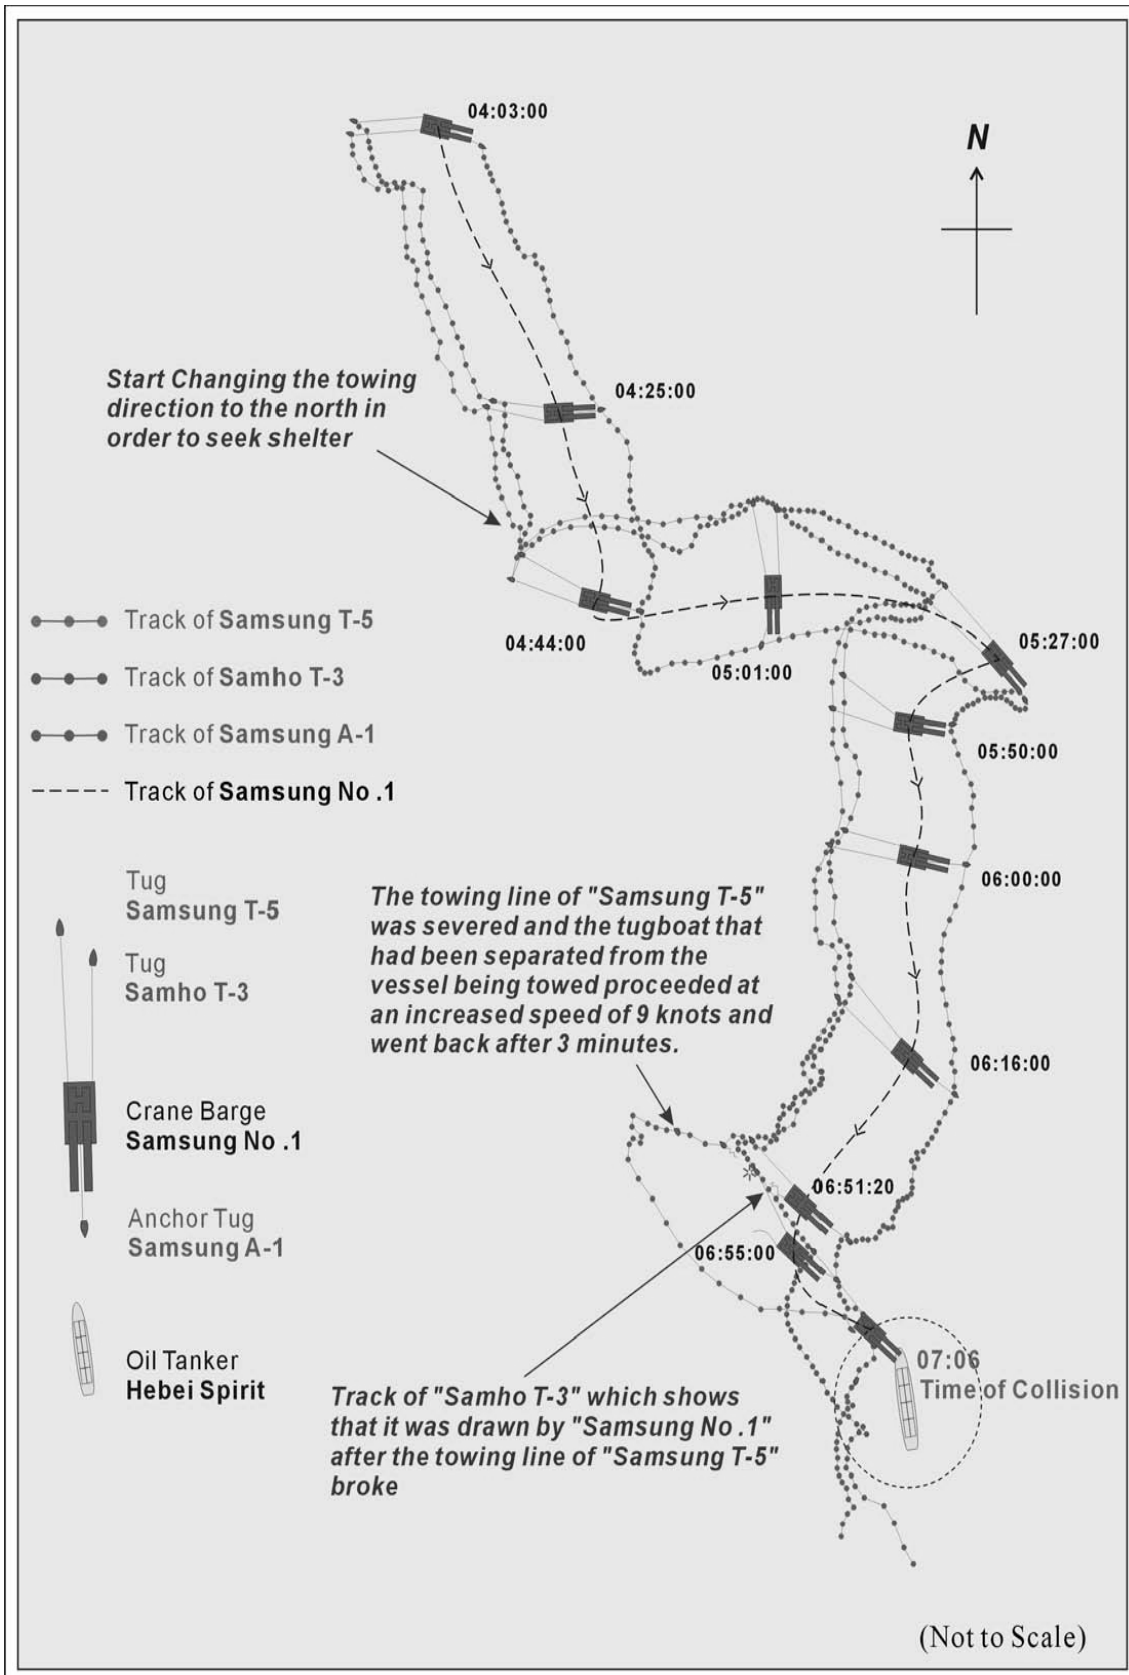
Fig. 7 Probable tracks of the towing convoy before collision

4.2.10 Due to the poor weather situations, the towing capability of the towing convoy could not overcome the weather conditions. The Master changed its course from west to a northern direction at about 0444 trying to seek shelter by returning to Incheon Port but without success. After changing the course, the towing convoy was further drifted to south (fig. 7).

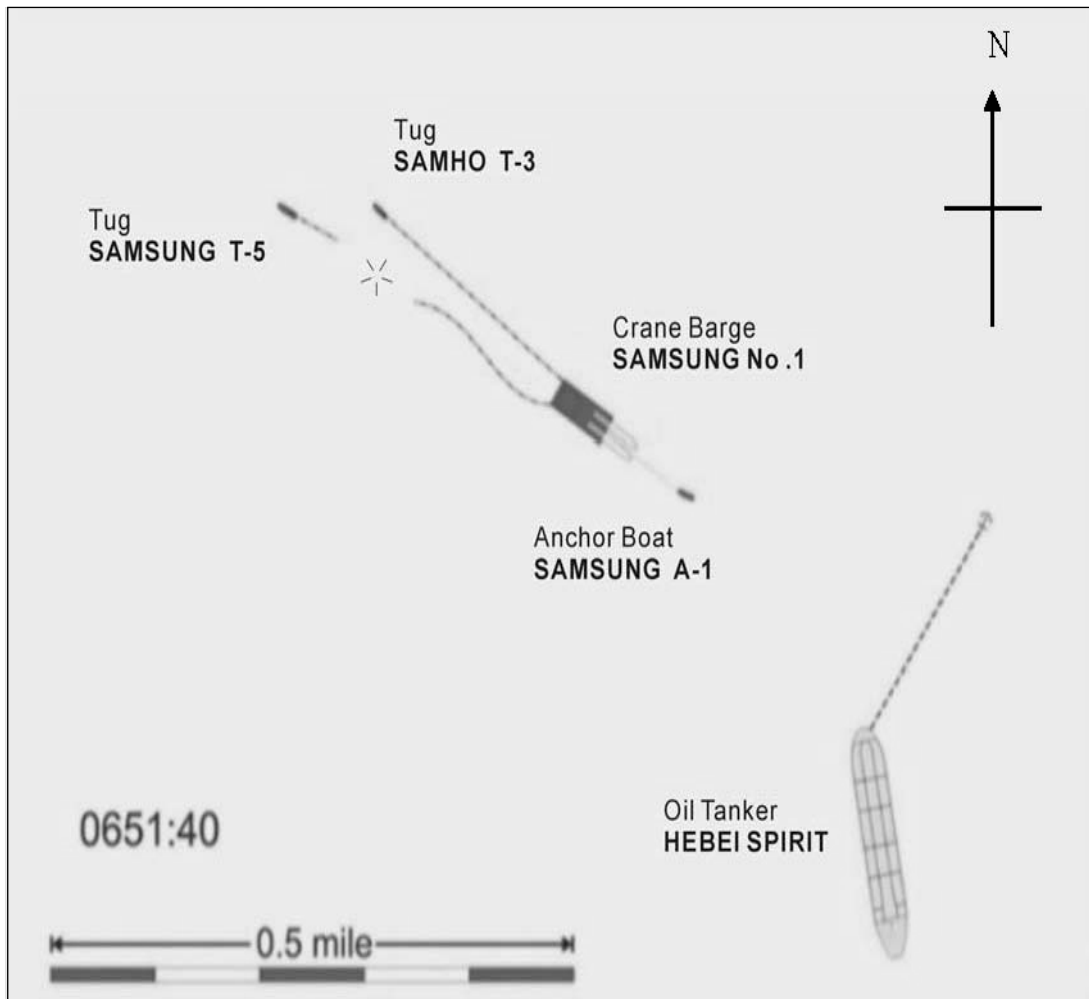
Fig. 8 Sketch of the approximate relative positions of *“Hebei Spirit”* and *“Samsung No. 1”*

5.3.7 After passing the bow of *“Hebei Spirit”* the towing convoy increased the speed. However, in about 10 minutes’ time after the increase, the towing wire parted. The Master in charge might have considered an attempt to increase the speed from avoiding further setting towards the *“Hebei Spirit”*. However, an increase of speed in rough sea condition might exert additional strain at the towing wire as a result of increase of force application. This would become critical if the towing wire was already pulled at its limit.

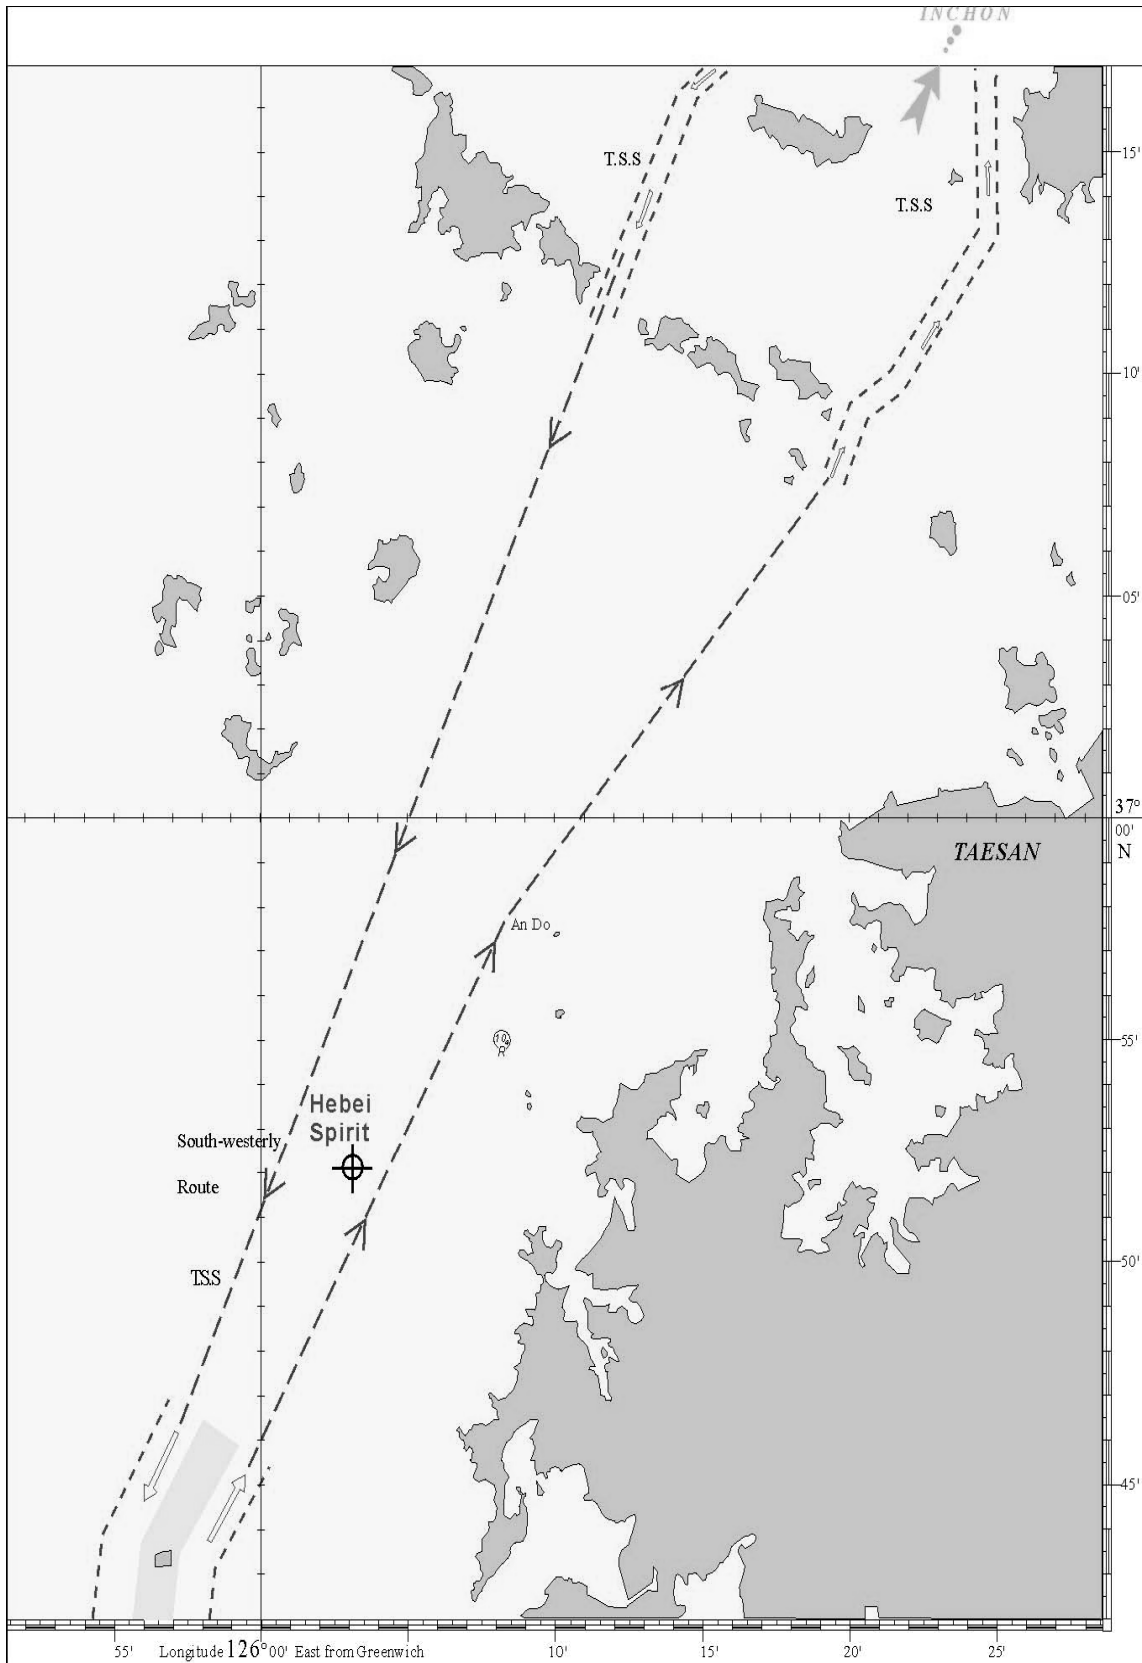
Fig. 9 Approaches to Incheon

5.6.2 To the north of this anchor position there are two traffic separation schemes (TSS) (37°15'N 126°15'E); one for inbound (Tong Sudo) and the other for the outbound traffic (Pando Sudo) of Incheon. To the south there is another TSS at west of Ong Do (36°40'N 126°00'E) guiding the north and southbound traffic. For traffic proceeds to Incheon from south the course adjoining the TSSs would cause the traffic to pass less than 1 nautical mile from the VLCC anchored position. For traffic from Incheon to south, the traffic would pass at about 2 nautical miles from the anchor position (fig. 9).

5.6.3 In this incident it is believed that the towing convoy might have originally planned to shape a south-westerly route of about 210 degree to join the TSS at west of Ong Do. With this course the towing convoy would have passed about 2 nautical miles from the anchored position of *"Hebei Spirit"*. However, due to the rough weather and loss of control, the towing convoy drifted towards the VLCC anchorage. As the anchored position was located between the routes of the passing traffic to and from the port of Incheon, it appears that the VLCC anchorage is too close to the passing traffic.

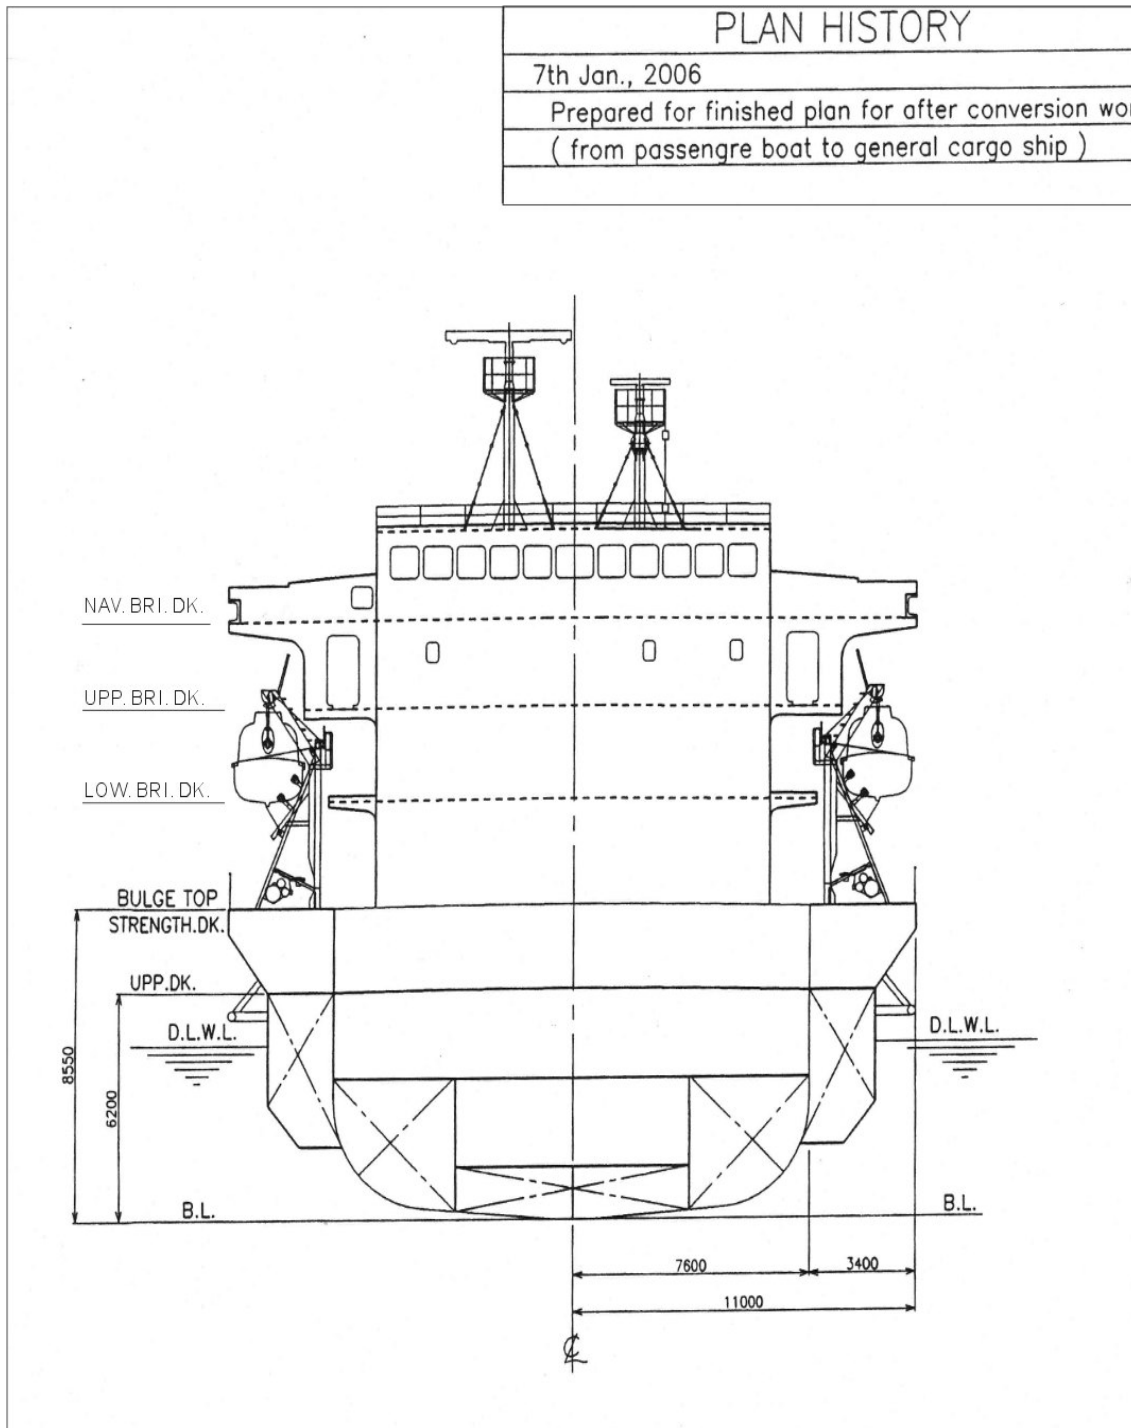
Figure. 5 – Front view of *Joshu Maru* showing the various decks to the Navigating Bridge.

- .3 In addition, the ship was so designed that the Master's cabin was located on the upper deck that was four decks below the navigating bridge. In this incident, it took the Master about 20 to 30 seconds to climb upstairs passing the unsheltered "Strength Deck", the "Lower Bridge

Deck” and the “Upper Bridge Deck” to reach the bridge. Hence the OOW should be made aware that it took times, about 20 to 30 seconds, for the Master to reach the bridge should the Master be called for assistance.

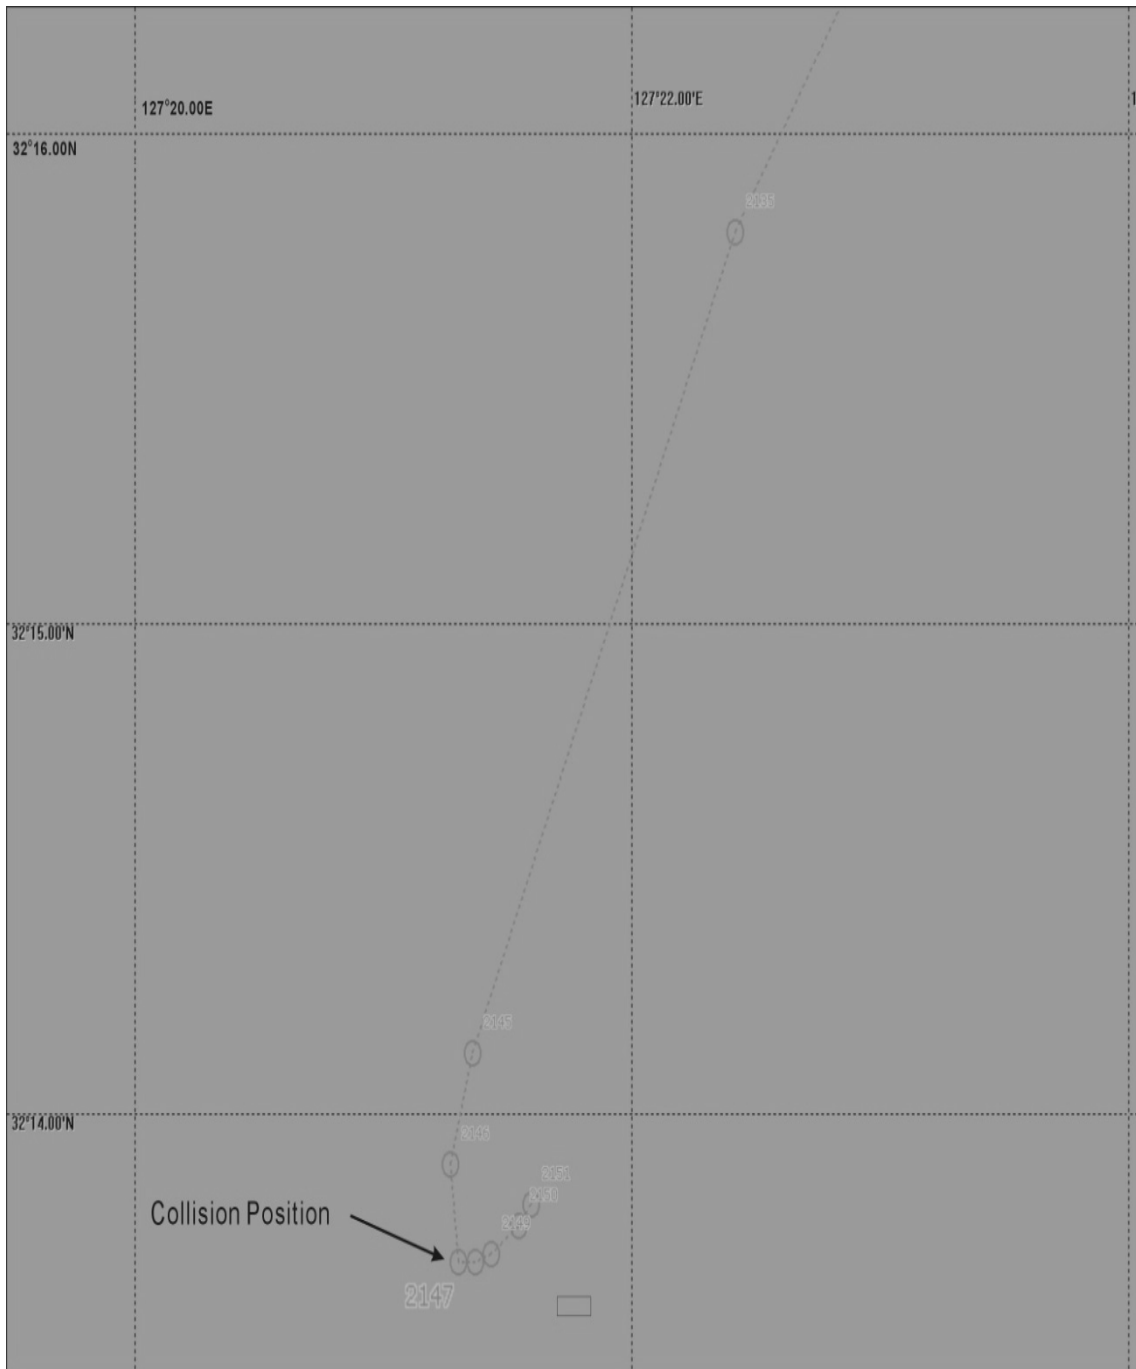
Figure. 6 – Chartlet showing the track of *Joshu Maru* before and after the collision.

- .1 According to the AIS information, the track of *Joshu Maru* before and minutes after the collision is plotted and shown in Figure 6 and Figure 7.
- .2 However there is not sufficient information regarding the positions and the track of the involved fishing vessel *No.3 Dae Kyung*. No relevant AIS and VDR information are available

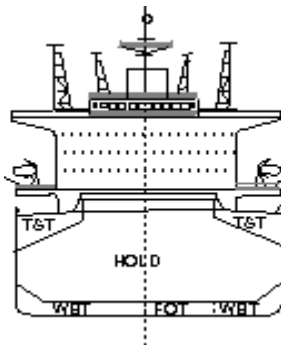
Figure 1 General Arrangement

As shown in [Fig. 1], the ship's wheel bridge was located in the stern, was divided by an FPT (fore peak tank), cargo hold areas (nos.1~5), an engine room, and an APT (after peak tank) in the bottom part of the upper deck. There was an accommodation area and a wheel house over the engine room. With a cantilever type body, there was a double bottom tank which was used for storing the cargo oil or ballast water in the bottom part of the cargo hold areas, while the topside tanks were located on each side of the upper area.

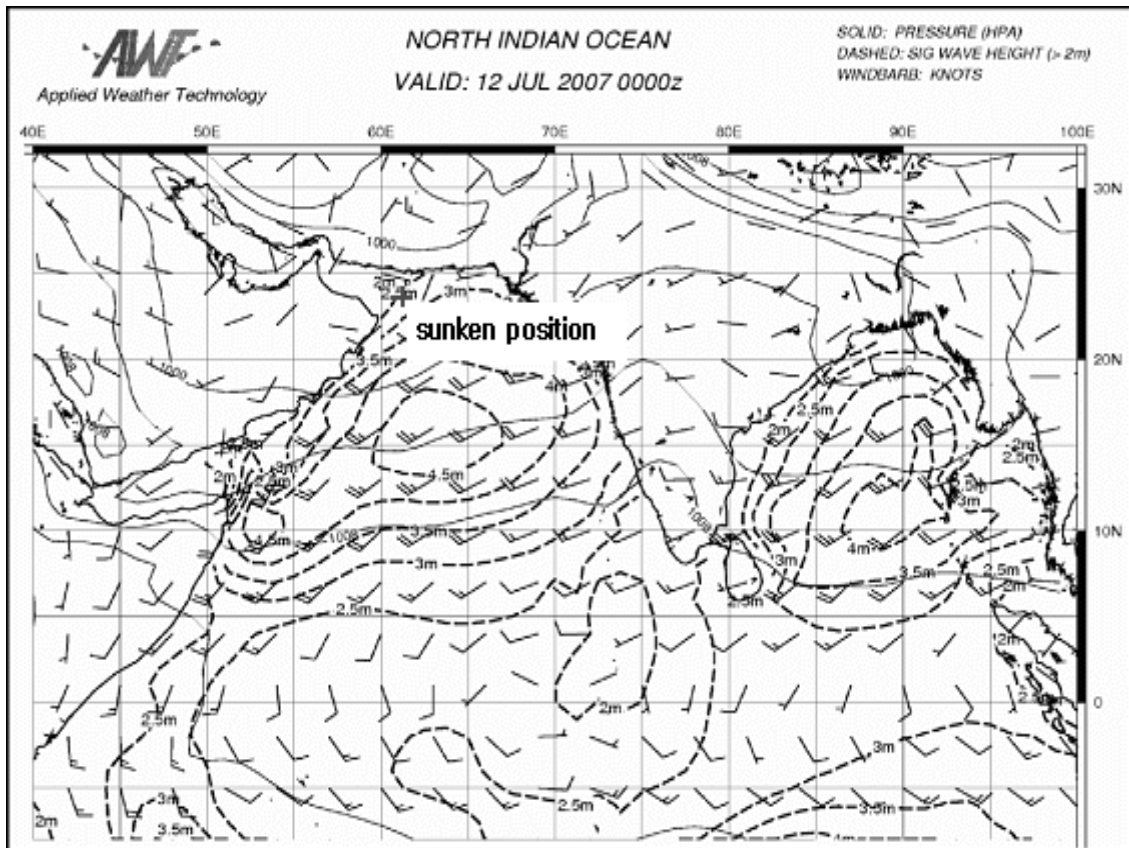
Figure 4 the sunken position of the ship

As crew members were lowering the lifeboats to the boat deck, the ship, still navigating to north at a speed reduced to about 3 knots due to excessive dropping, lost its balance a couple of times followed by an excessive noise like 'pa-pang', and eventually sank from the bow, at a position of about 082° from its true course, about 107 miles from the lighthouse of Masqt, Oman, at around 03:22.
